## Performance of naturally durable eucalypt posts in Marlborough vineyards.

Authors: Paul Millen and Clemens Altaner

**Date:** 26<sup>th</sup> October 2017

Publication No: SWP-T039

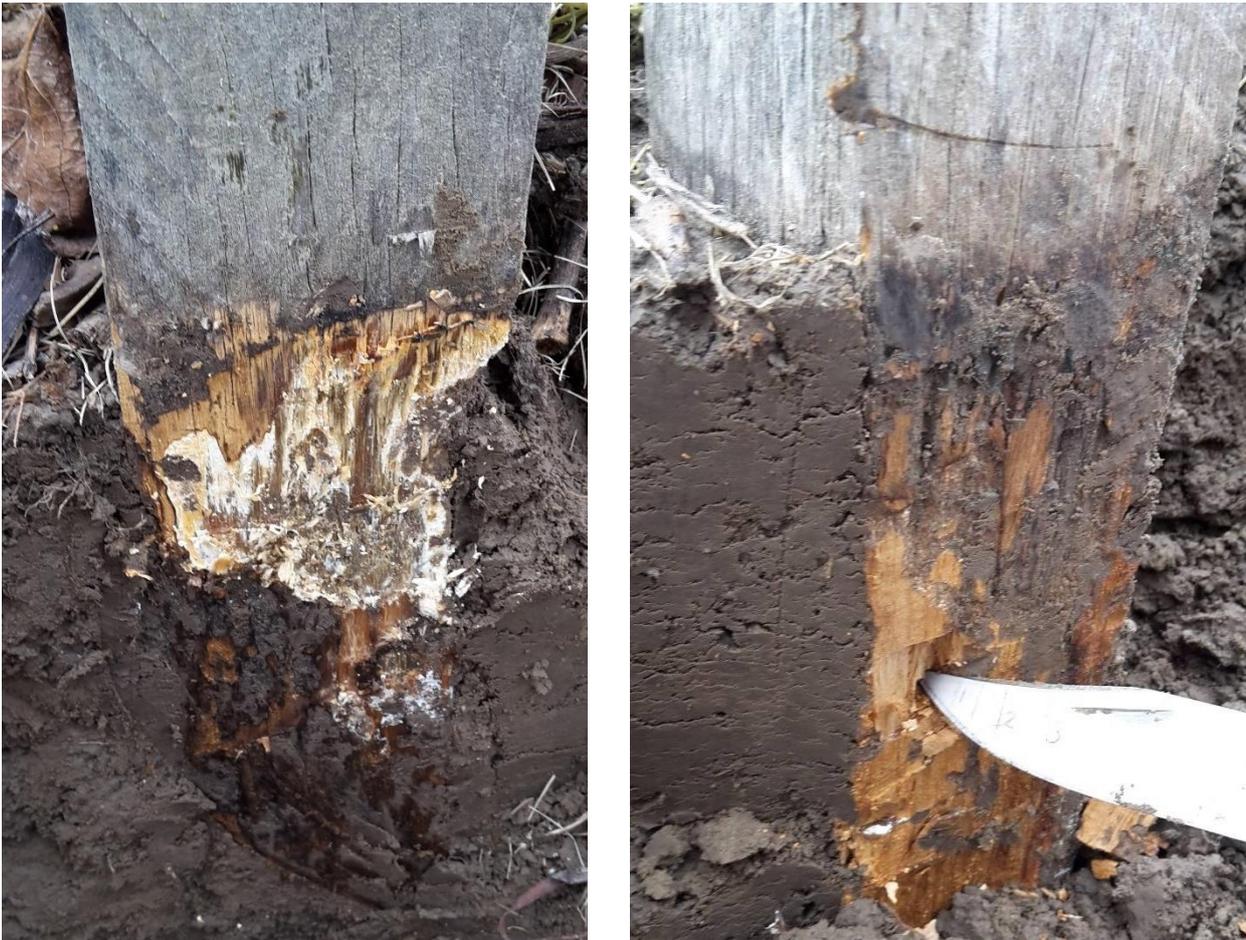
White-rot and brown-rot (and possibly soft-rot) were found on posts of both species (Figure 3).

Figure 3: White-rot (left) and brown-rot (right) on *E. bosistoana* posts after 10 years in service (post 36 and 40)

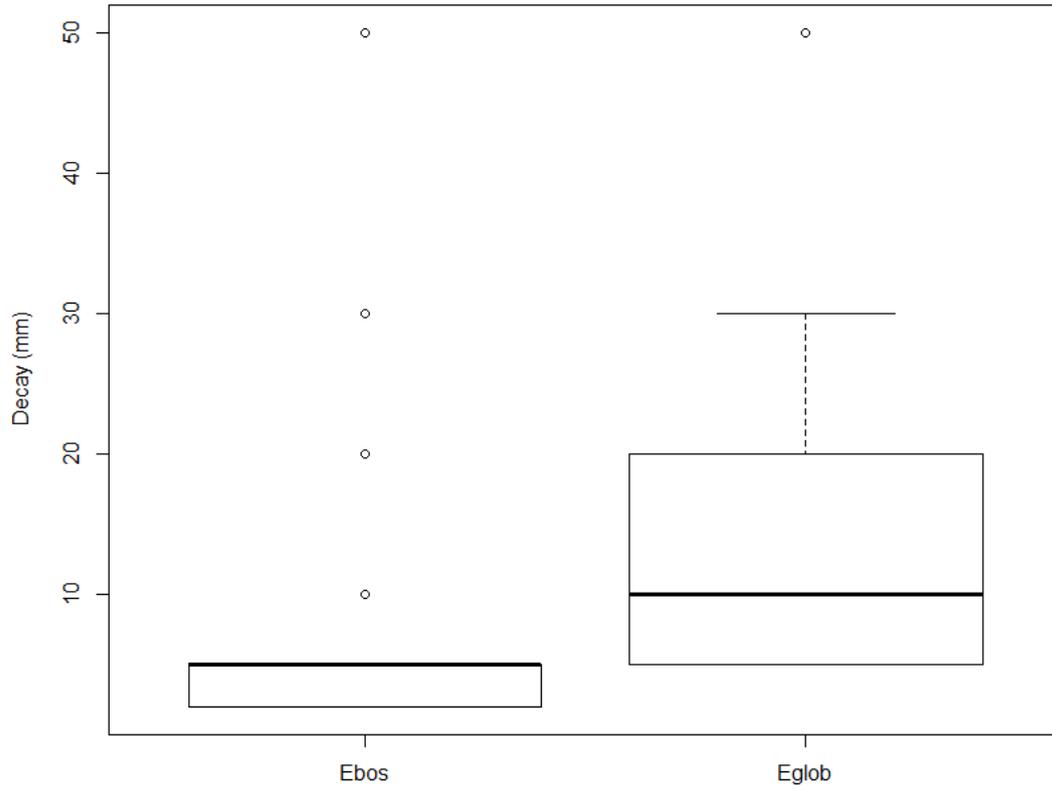
Generally, *E. bosistoana* posts showed less decay than *E. globoidea* posts after 9 -11 years in service (Figure 4). However, this analysis was confounded by site, as not all sites had posts from both species.

Figure 4: Decay depth of *E. globoidea* ( $n=63$ ) after 10 years and *E. bosistoana* ( $n=73$ ) posts after 9-11 years in service. Note: confounded by site.

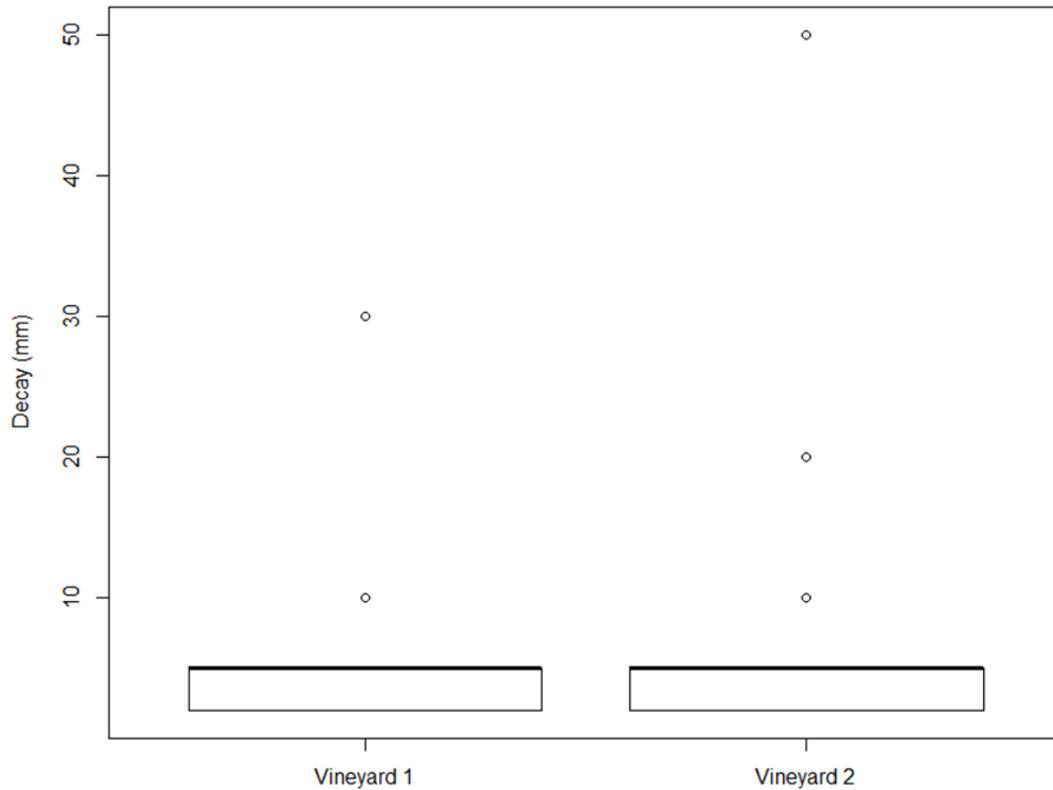
*E. bosistoana* posts performed well at both assessed sites (Figure 5) with many posts showing no sign of decay. The full range of decay assessed in *E. bosistoana* posts is shown in Figure 6. This is what would be expected as there is natural variation in the decay rates of wood from different trees of the same species as well as variation in the wood in different parts of the stem. These natural variations are noted in the Australian Standard AS5604 as '*the inner heartwood (the first few growth rings around the pith), generally, has lower natural durability than the rest of the heartwood*'.

Figure 5: Decay depth of *E. bosistoana* posts at vineyard 1 ( $n=50$ ) after 10 years and vineyard 2 ( $n=23$ ) after 9-11 years in service.

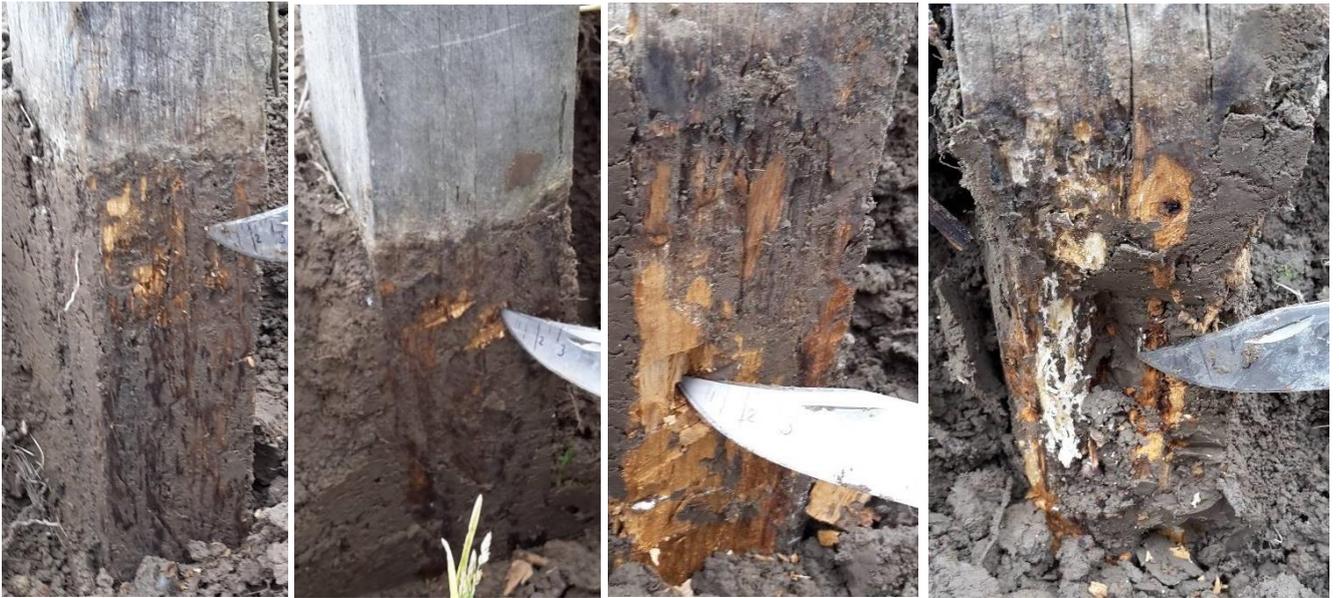
Figure 6: Range of decay in *E. bosistoana* posts after 10-11 years in service. From left to right: < 2mm; 2-5 mm; 10-20 mm; > 30mm (post 10, 21, 40 and 41). Note: post 41 showed the severest decay of all assessed *E. bosistoana* posts.

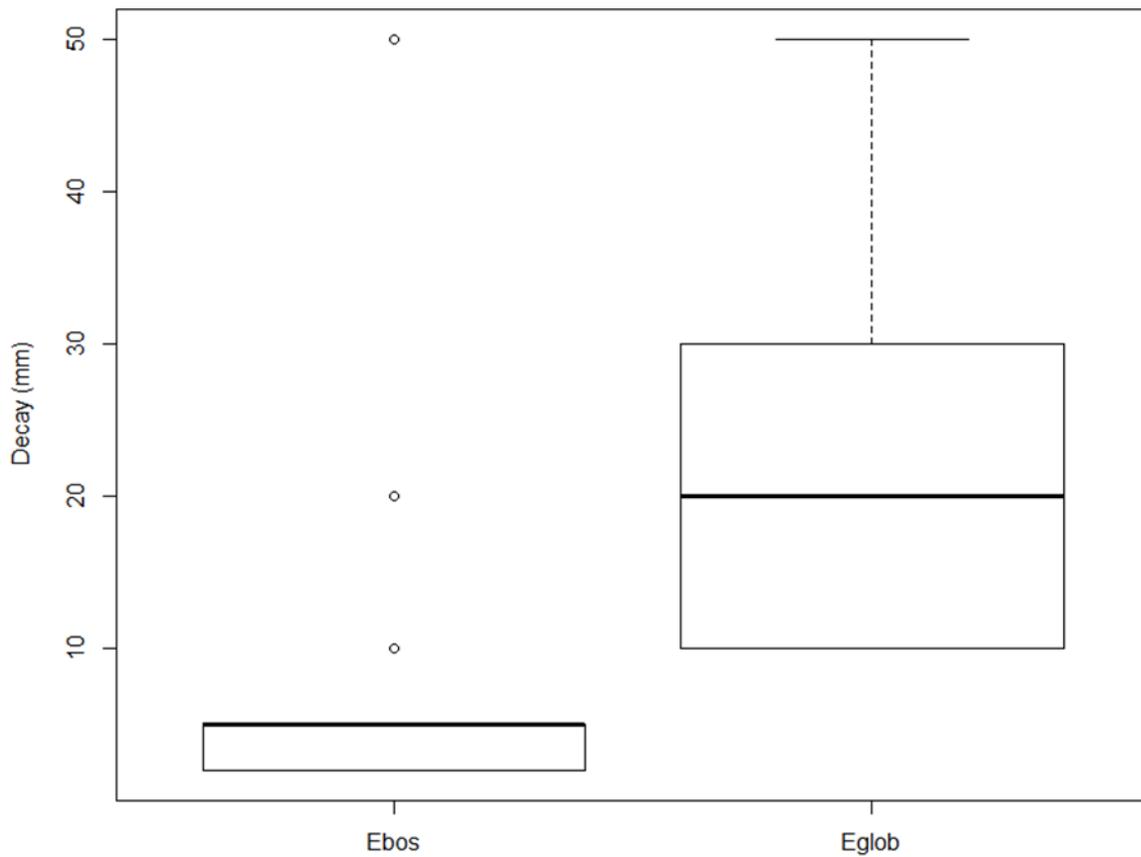
Figure 7: Decay depth of *E. globoidea* (n=25) and *E. bosistoana* (n=23) posts after 9-11 years in service.

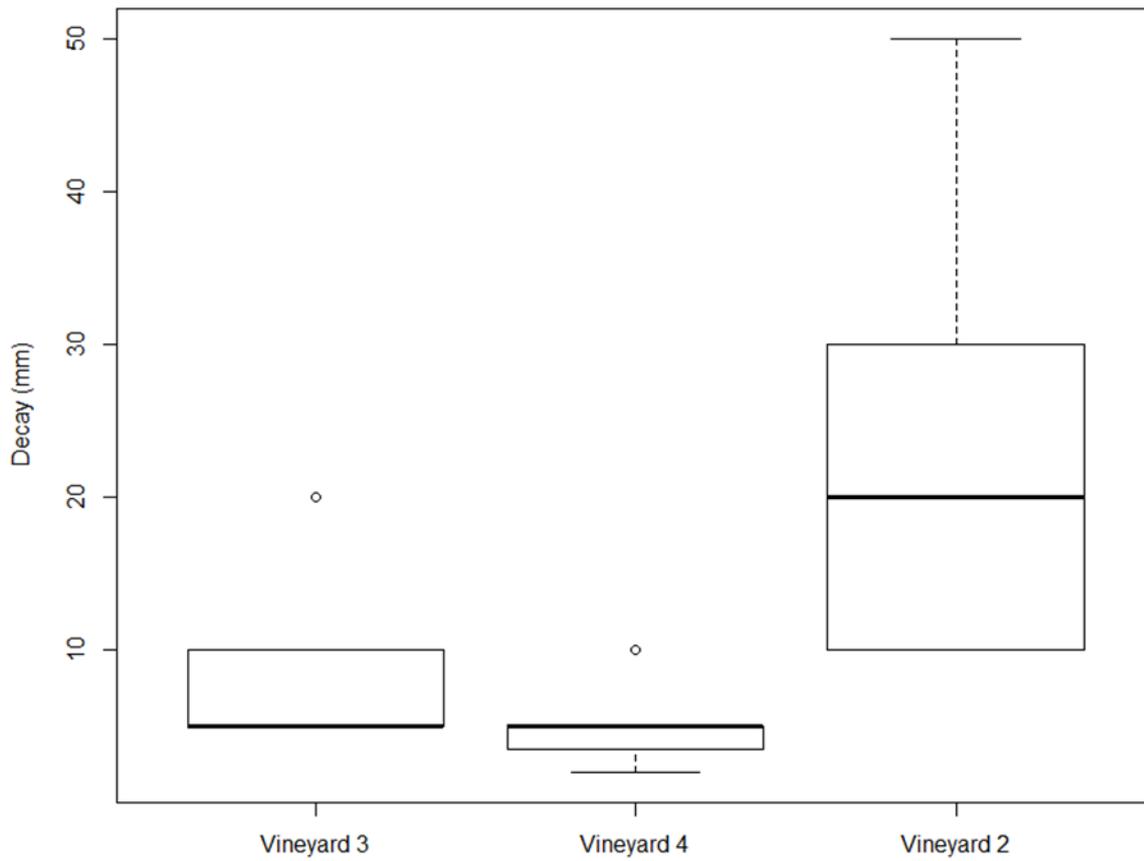
Performance of *E. globoidea* was site specific (Figure 8). After 10 years in service posts at vineyard 2 showed severe decay while posts in the feijoa orchard at vineyard 3 (also in service for 10 years) were performing well (Figure 9). One possible site effect is the under-vine cultivation at vineyard 2 compared to the undisturbed soil at vineyard 3.

Figure 8: Decay depth of *E. globoidea* posts at vineyard 3 (n=38) after 10 years; vineyard 4 (n=12) after 5 years and vineyard 2 (n=25) after 10 years).

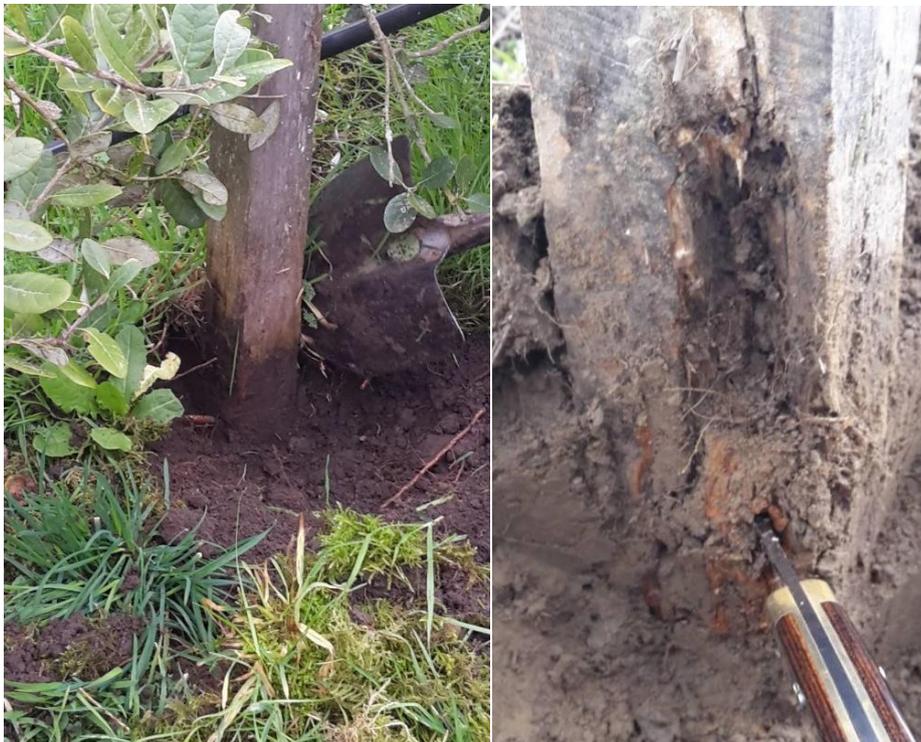
Figure 9: *E. globoidea* posts after 10 years in service. Post 116 in feijoa orchard at vineyard 3 showing no sign of decay and failed post 62 at vineyard 2. Note: Post 62 showed the severest decay of all assessed *E. globoidea* posts.

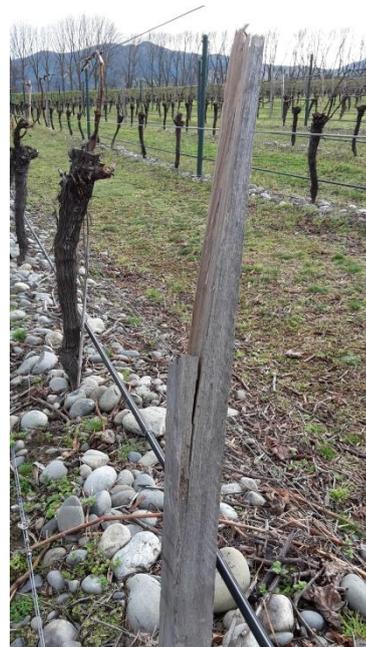
Figure 16: *E. bosistoana* post broken by machine harvester in vineyard 1.

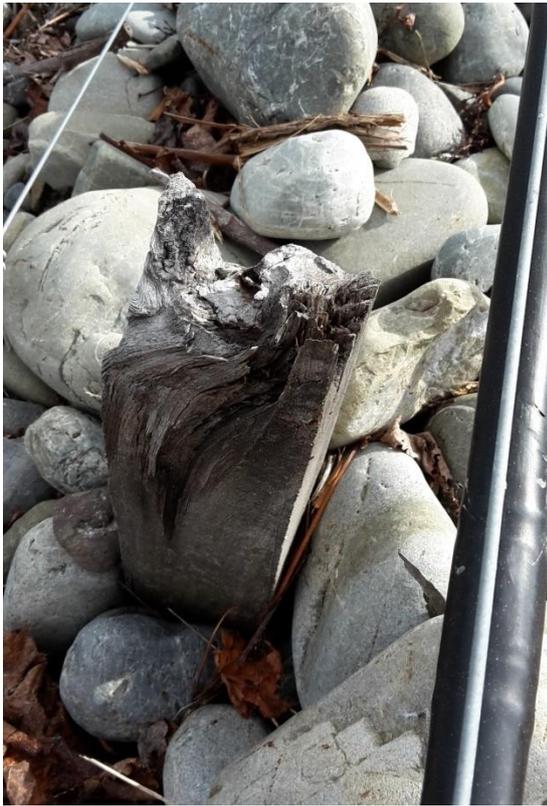
He commented that since installation the eucalypt posts *'have been fine and we have only broken one from memory. It was broken by a harvester, it had a knot in it and it snapped on the knot'*. He considered the eucalypt posts *'equal'* to others he had used which included CCA pine, steel, plastic coated steel and wallaba timber posts. The typical causes for failure in his vineyards were *'mechanical damage'*.

Figure 17: *E. bosistoana* post broken across knot in vineyard 1.

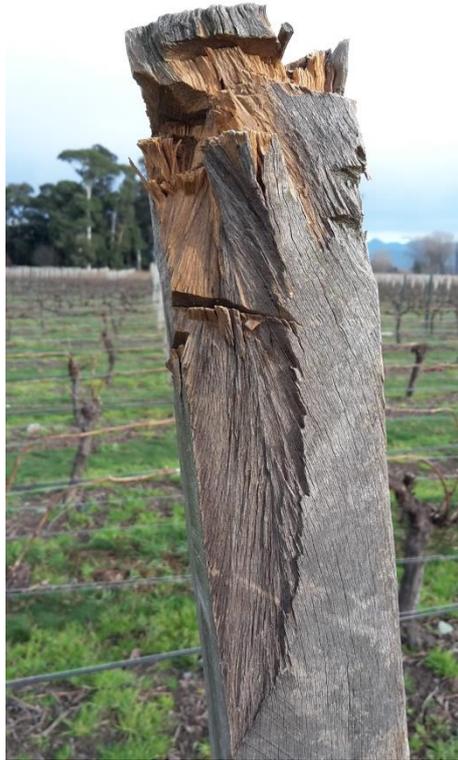
Figure 18: *E. bosistoana* showing repeated damage by machine harvester in vineyard 1.

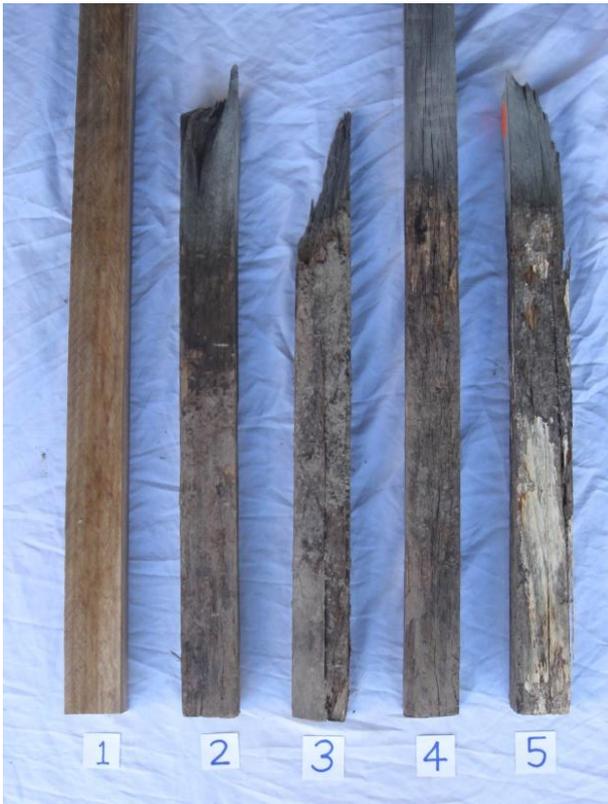
Figure 19: Sections of *E. bosistoana* postss with no. 1 unused timber and no's 2,3,4 & 5 all sections of broken posts dug out of vineyard 1 after 10 years in ground. Note no. 5 is pith wood.

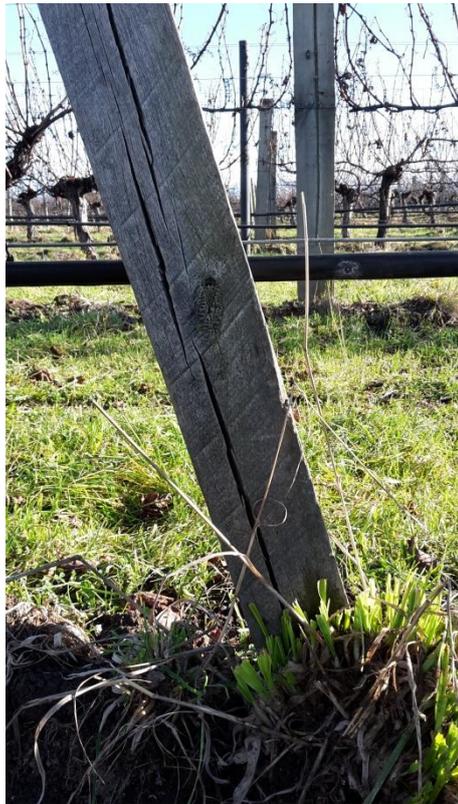
Figure 20: Broken half round CCA pine post in vineyard 2.

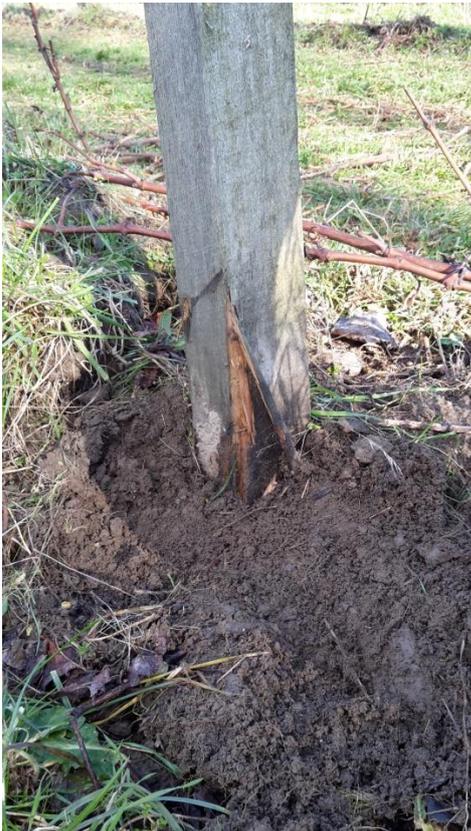
Figure 21: *E. globoidea* post with recent damage by mechanical undervine cultivation in vineyard 2.

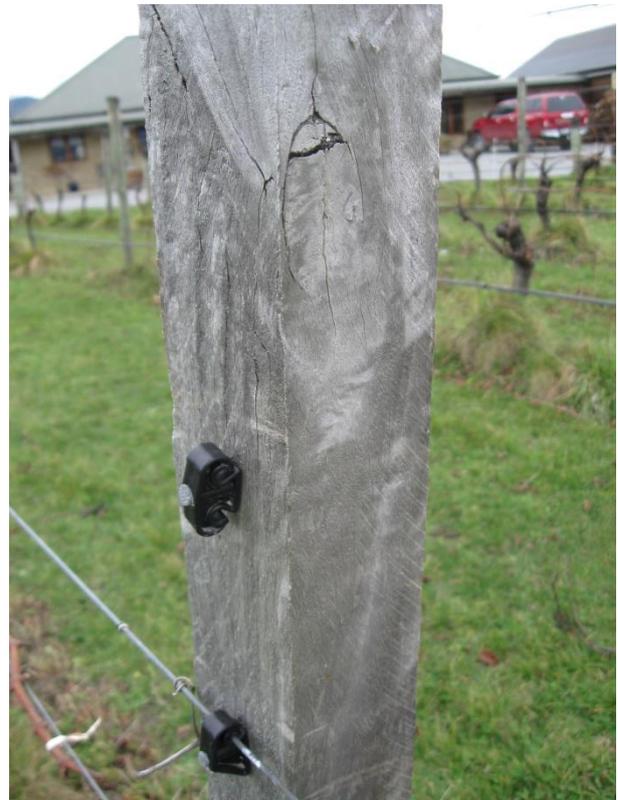
Figure 24: *E. globoidea* showing wire hangers fastened with clouts at vineyard 4c. Note the size of the spike knot.

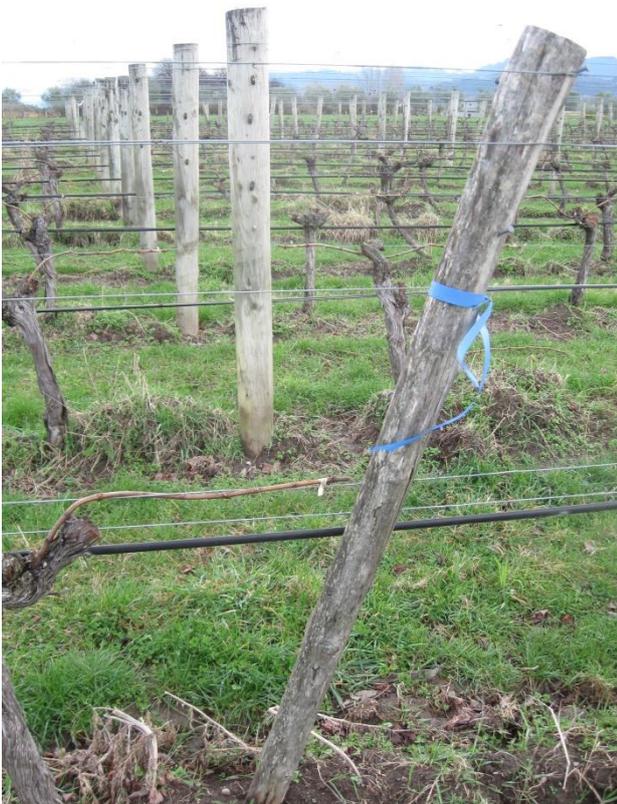
Figure 30: Imported teak round post decayed at just below ground level and marked for replacement in vineyard 5.

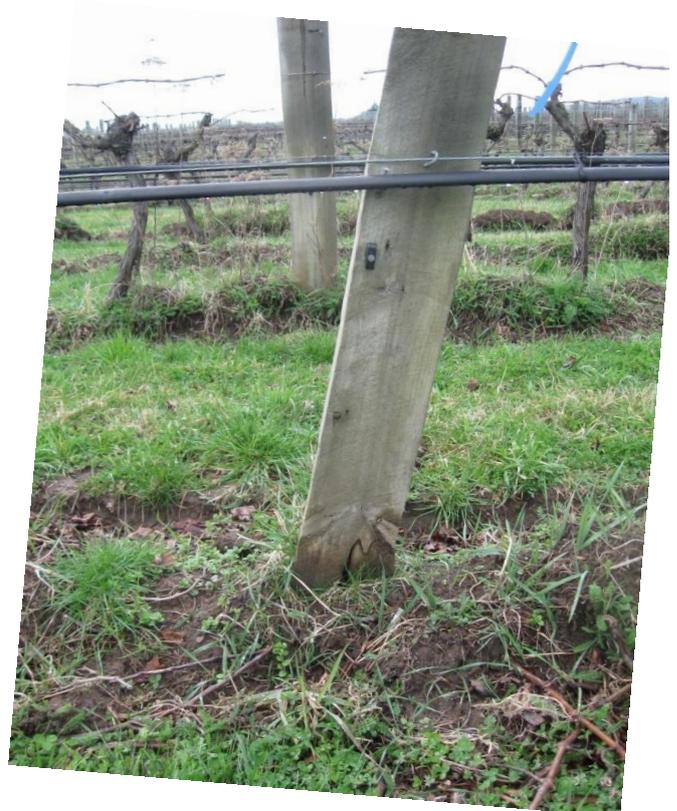
The typical causes for failure in his vineyard have been *'after vineyard establishment there was failure of weaker posts due to branch whorl being at ground level and then hit during pruning and high winds. Fewer posts fail now and generally caused by mechanical harvesting'*.

Figure 31: CCA treated pine post cracked across branch whorl at ground level and marked for replacement in vineyard 5.

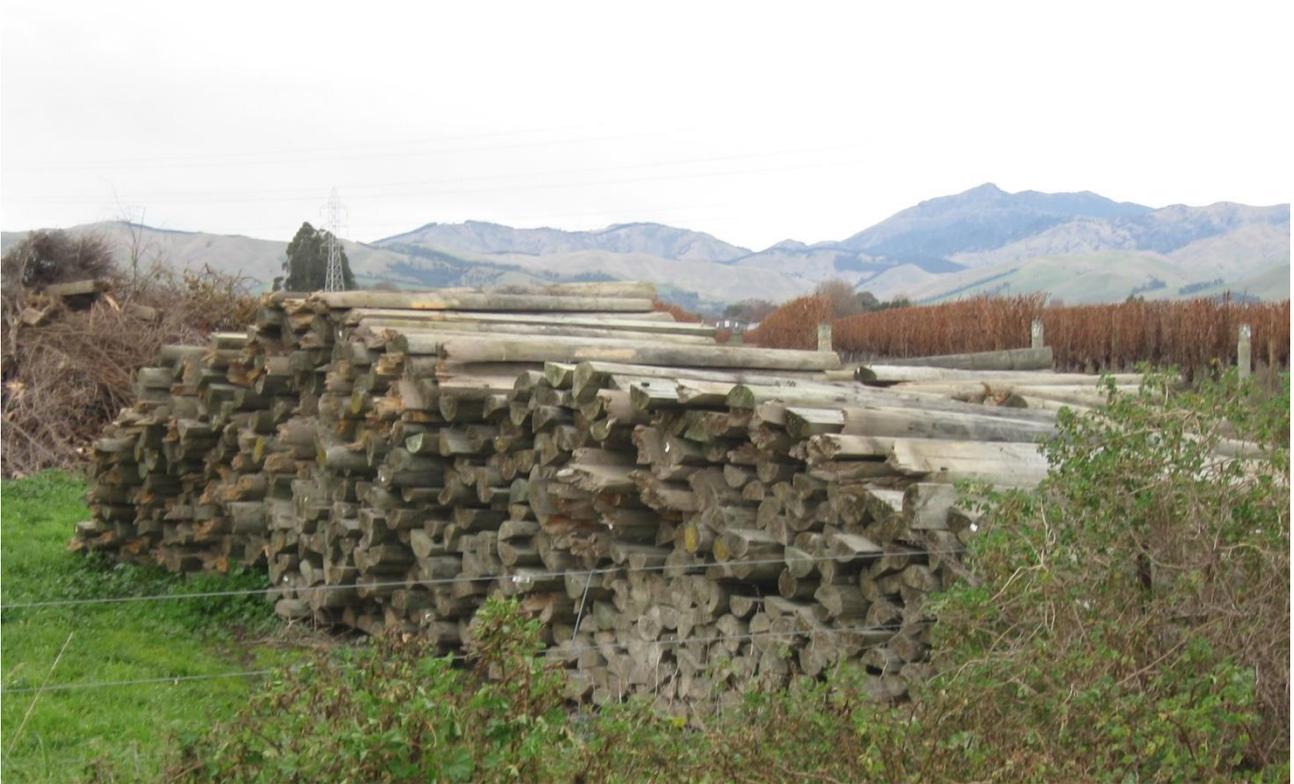
*Figure 32: View of broken CCA post stock pile in an adjoining vineyard to one of those assessed.*

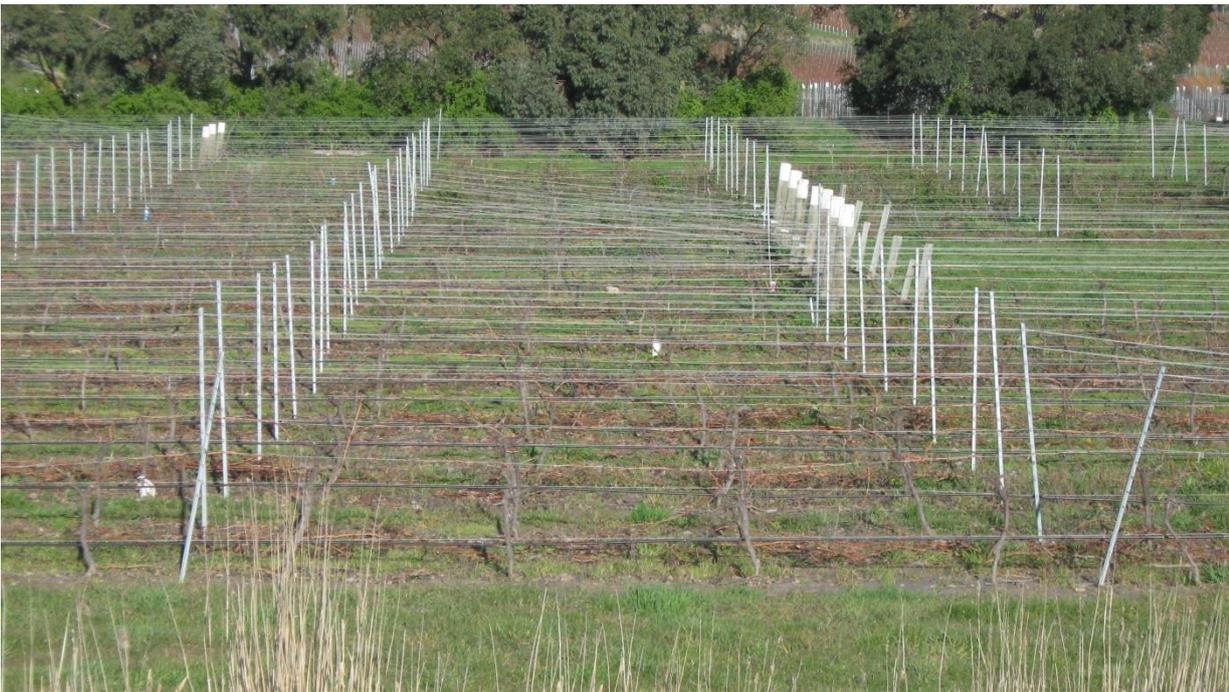
*Figure 33: View of a Marlborough vineyard using all steel posts with some showing the impact of machine harvesting.*
